THE EFFLORESCENCE REPORT

February 2009 by Harold B. Newman, CrE

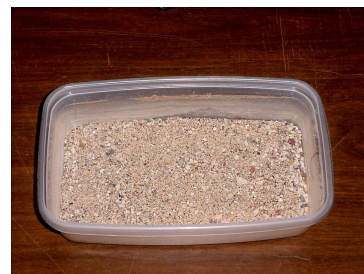
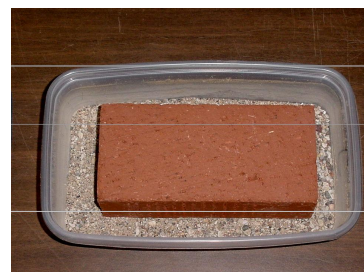
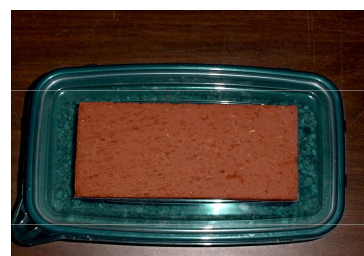
In these ongoing studies, various materials were tested for soluble salts measuring cation and anion concentrations using an ion chromatograph. A modified efflorescence test was run whereby clay pavers, which did not show any evidence of efflorescence in the normal ASTM C-67 test, were set on beds of the various aggregate samples set up in individual plastic dish containers. A fixed portion of distilled water was placed in the container and a plastic lid was cut to expose only the surface of the clay paver to evaporation. The containers were placed in a controlled atmosphere with a fan blowing across the surface of the dish. Following 7 days of exposure, the samples were removed and dried in an oven and evaluated for the evidence of efflorescence. Several dishes were also included which did not contain any setting materials. See pictures right and below. *(Note: clay pavers used in this study were the Pine Hall Brick 4 x 8 Pathway units)*

Container Set Up-Efflorescence Test

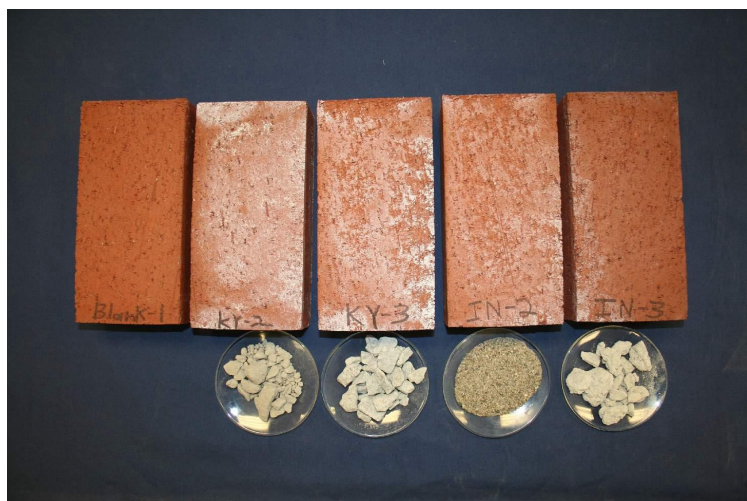
Aggregate Efflorescence Test Results (standard sample far left)

The National Brick Research Center concluded that there is a definite correlation between soluble anion & cation concentrations and the potential for efflorescence. A total of 6 out of 13 aggregate samples generated efflorescence on the pavers with none of the standard samples (without bedding material) showing any evidence of efflorescence. Early indications (from progress reports) show that there is a concentration threshold of 100 parts per million needed for efflorescence to occur and that source aggregates producing efflorescence had sulfate concentrations in excess of 100 ppm.

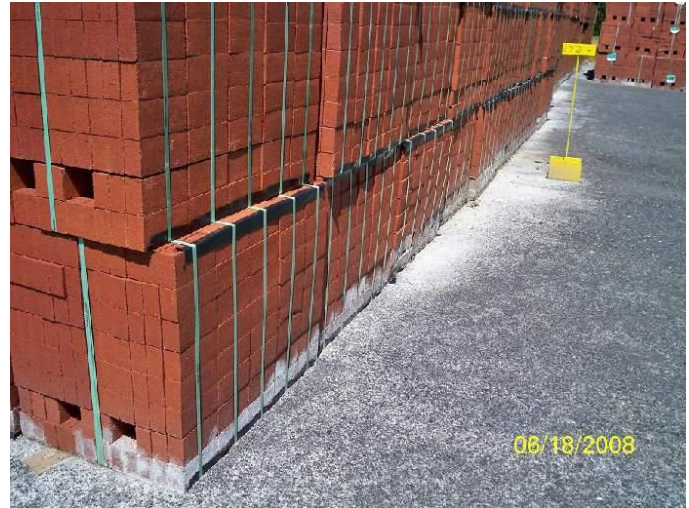
A good example of this would be when pavers are stacked on an aggregate base yard that is contaminated with soluble salts, either from its virgin location, in transit to the point of deposition, or from de-icing salts. When the surface of the yard gets wet, the salts are dissolved in water and migrate into the stack of pavers. When the pavers dry out, the transported salt shows up on the surface as efflorescence. See picture.
