Exterior & Interior Wall Systems Offered Exclusively by Acrylall, LLC

Technical Information

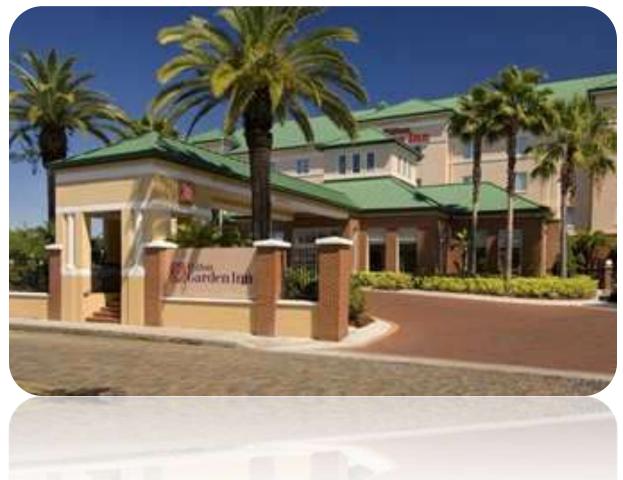
Hilton Garden Inn

Exterior Direct Applied Wall Finish System applied to CMU

Interior acrylic Knock-Down wall finish applied over Gypsum Board

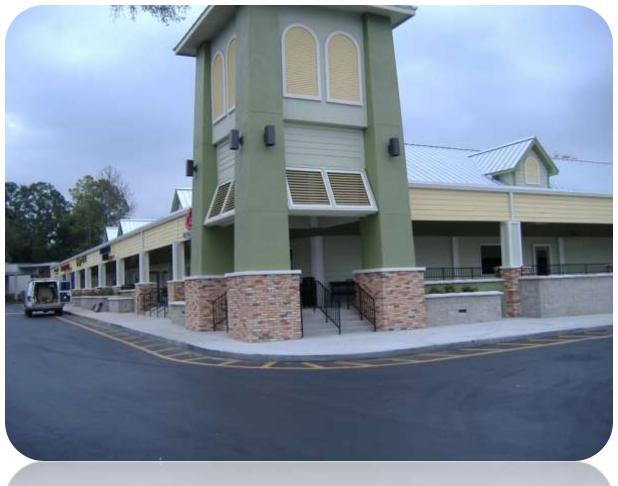
Wekiva Shopping Village

Exterior Direct Applied Wall Finish System applied to CMU and Exterior Sheathing.

Acrylall's product was applied at wall base to create the brick finish

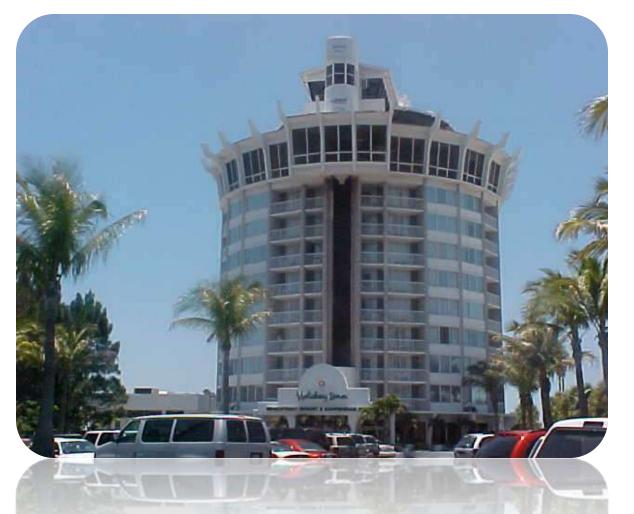
Holiday Inn Hotel

Renovation of existing hotel - Interior acrylic wall system

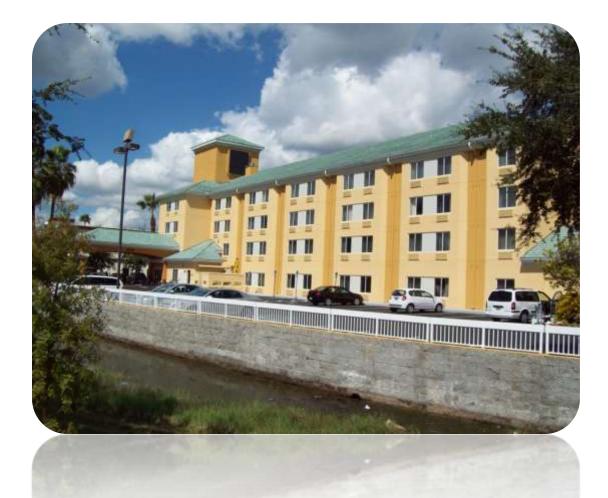
Best Western Hotel

Renovation of existing hotel

Exterior Direct Applied Finish System

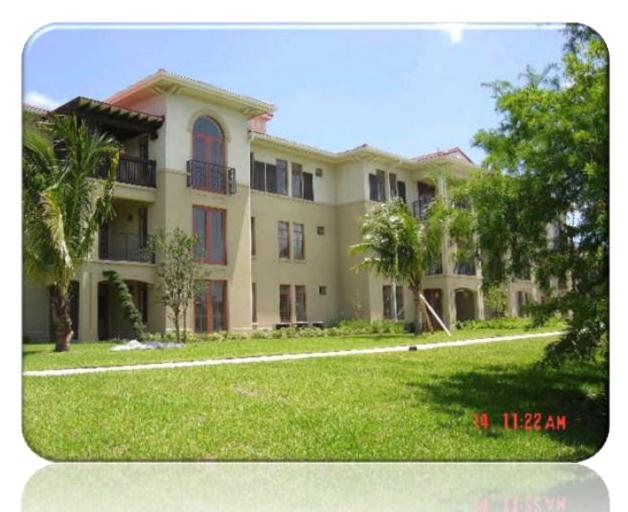
La Posada Senior Living Community

New construction: Exterior Direct Applied Wall Finish System applied to 600,000 sf of CMU - PIP - Exterior Sheathing

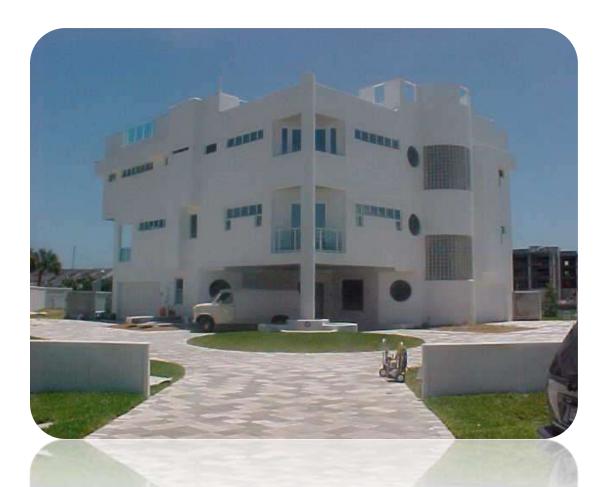
Custom Residential

Renovation of existing structure

Application of Bastion finish system to exterior of previously painted stucco

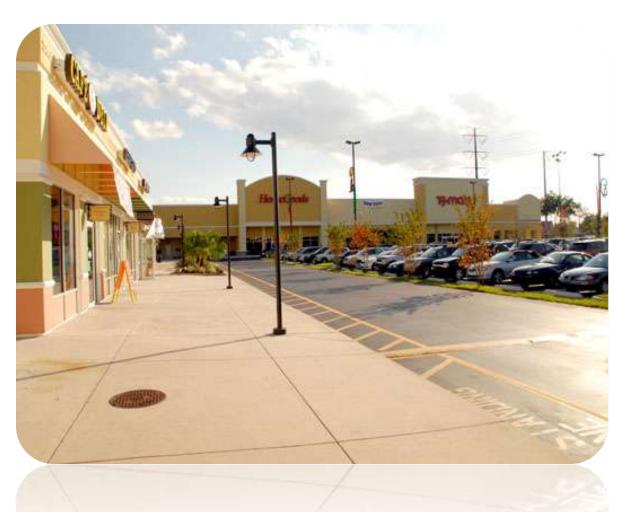
Lake Mary Village

Renovation of existing shopping center

Application of Bastion system over existing painted stucco and existing cracked EIFS

Addition of new foam shapes with Bastion finish

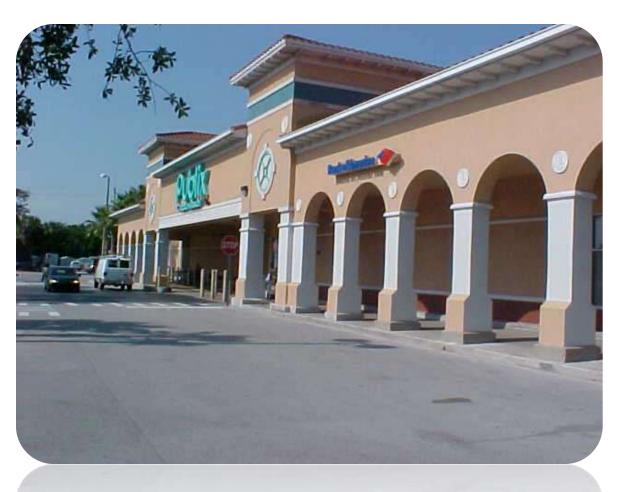
Publix supermarket

Renovation of existing exterior

Application of Bastion system

Previous substrate of cracked EIFS
